# Orbit Newsletter Digital Publication

## Value of Cylinder Pressure Measurement for Reciprocating Compressor

The Aromatic process plant's Hydrogen rich gas compressors are four throw, three-stage, double-acting horizontal API618 reciprocating compressors with 40,122 Nm<sup>3</sup>/h output.

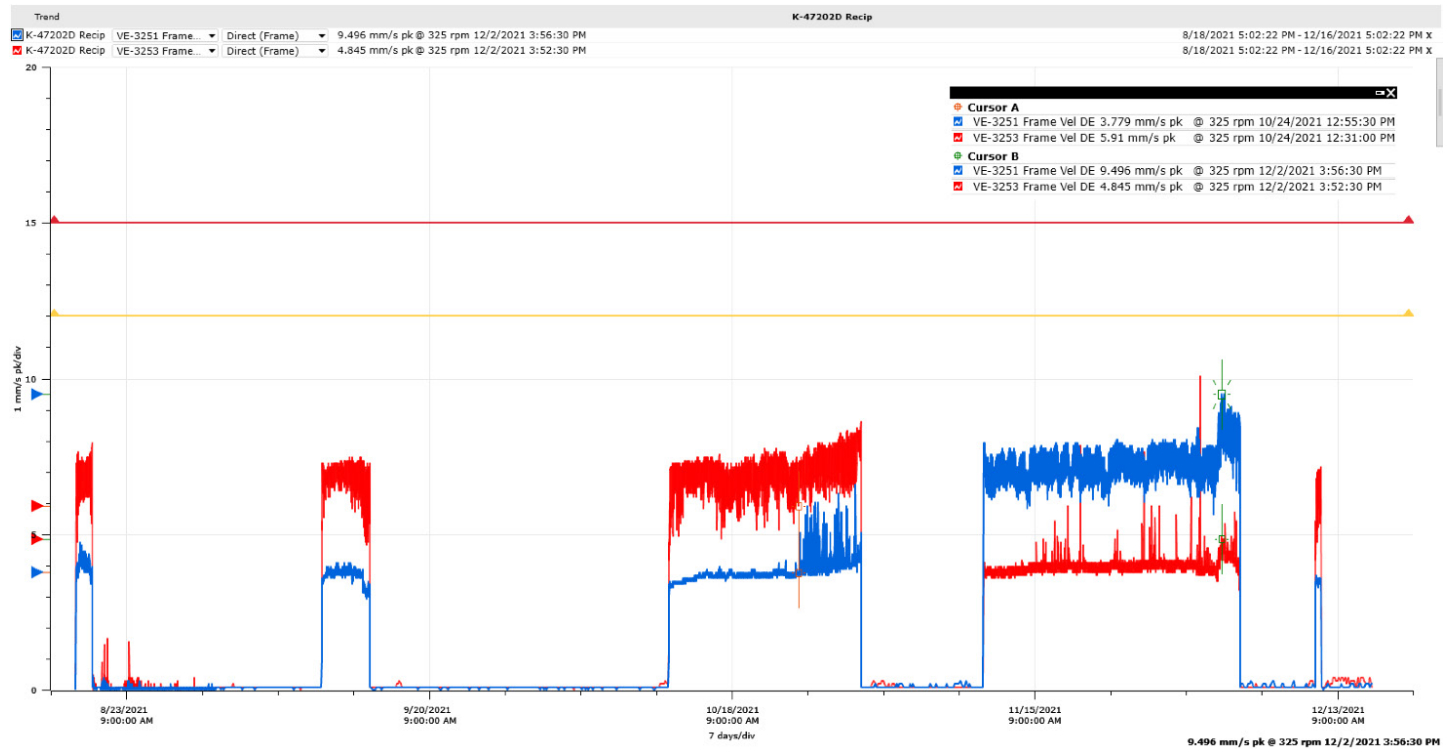
Figure 3. Frame Vibration Trend

The following trend plot, Figure 3, indicates that the frame vibration had a step change back on December 2nd. However, this plot is not sufficient to determine a root cause of the vibration trip. Deeper diagnostic analysis is required.:

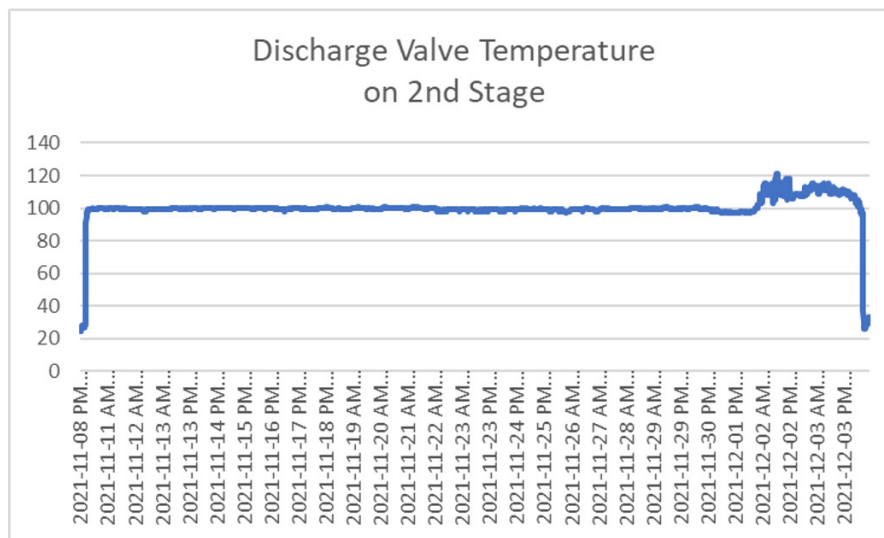
Figure 4. Valve Temperature Trend in DCS

The header temperature and pressure trends, as measured by DCS, were reviewed (Figure 4), but root cause of the machine trip could not be determined with this data. It was confirmed that both of CE (crank-end), HE (head-end) temperature and the pressure had both changed from around 2nd December as shown in the temperature trend plot below.

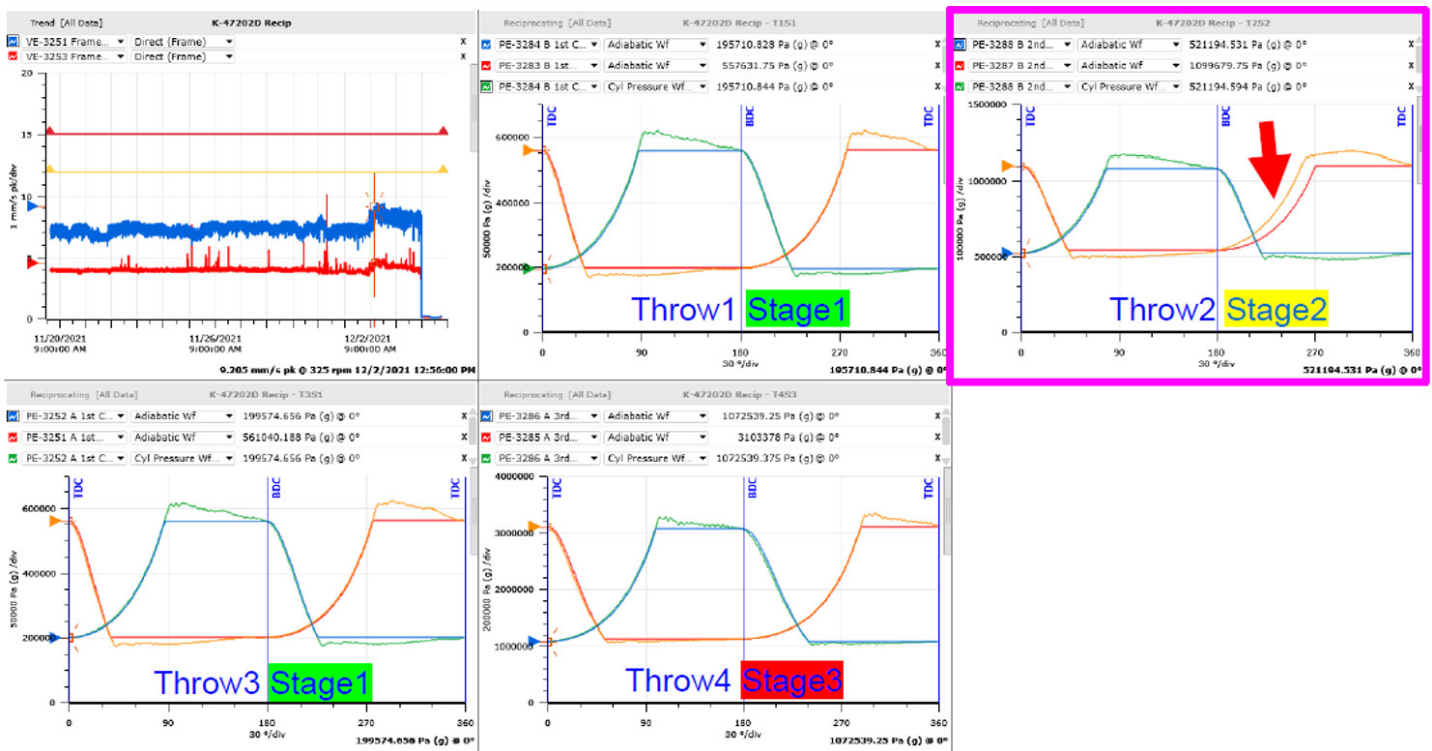
Figure 5. P-θ plot for Each Throw

Bently Nevada's System 1<sup>®</sup> is capable of measuring and monitoring the essential condition monitoring parameters for reciprocating compressors. In this case, System 1's P-θ (Pressure vs Crank Angle) plot for Throw 2 clearly indicated a more rapid pressure increase than the expected value curve, and a significant reduction in flow balance on the Head End chamber for the same Throw from around 2nd December. (Refer Figures 5, 6 and 7 below)

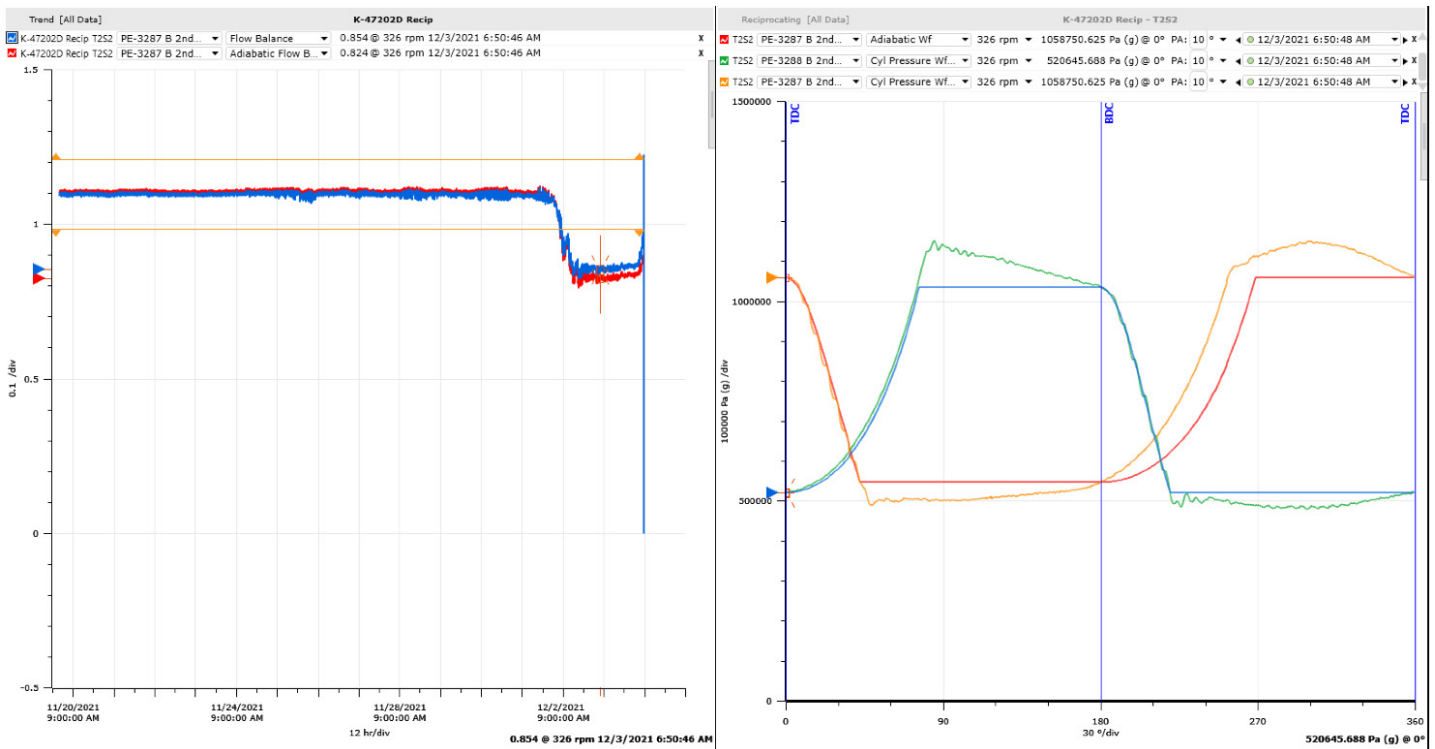
Figure 7. Flow Balance and  $P-\theta$  plot Change on 2nd Stage Throw

After reviewing the various data captured by System 1®, S-Oil concluded that the root cause of high frame vibration was, in fact, an issue related to the Head End discharge valve on Throw 2.

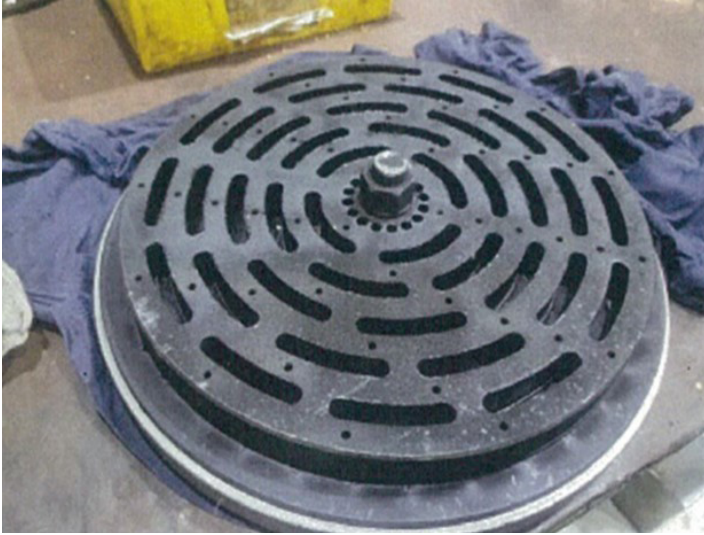
Figure 9. HE Valve

An inspection was scheduled for the Throw 2 Head End discharge valve specifically, as opposed to the traditional approach of opening and inspecting all valves. Clear damage to the discharge valve ring plate was found as shown in pictures. (Refer to Figures 9 and 10 below)
