Orbit Newsletter Digital Publication

Q3 2022

Reliability improvement for reciprocating compressor in CCR reformer process

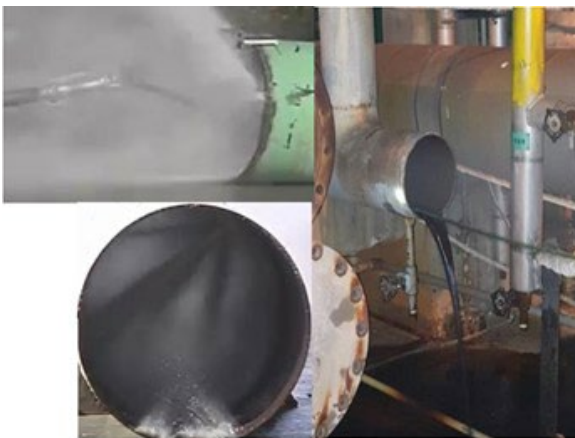
Figure 8. Water washing and purging on the pipe

To avoid further generation of green oil, catalysts like Fe_2O_3 and Cl_2 were completely purged from the piping system and the knockout drum to the discharge line during turnaround maintenance.

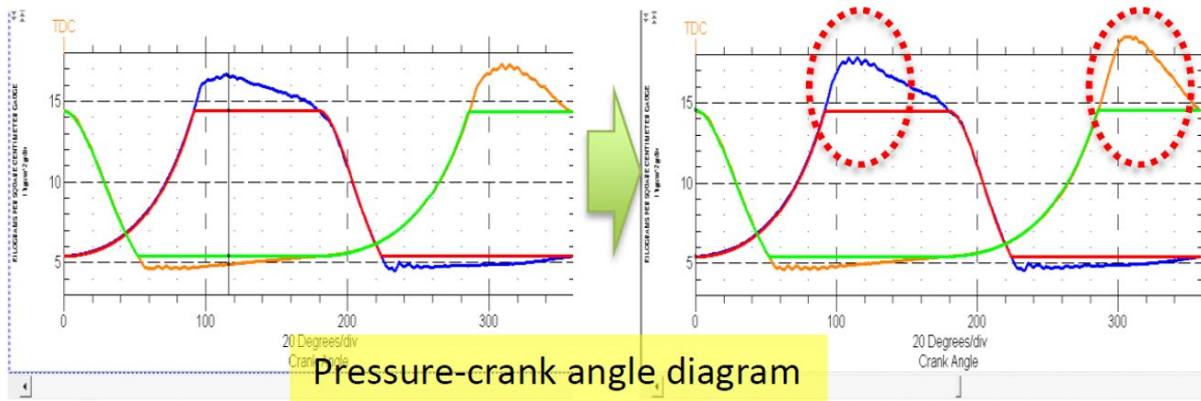
Figure 13. Determine valve maintenance timing

Based on the review, it was determined that the maximum pressure inside the chamber tended to increase over normal values whenever a foreign substance entered the chamber, and subsequently deposited or built up around the discharge valve, preventing the valve from operating properly. Therefore, it was postulated the effective compression ratio was higher than typical ratio of discharge pressure to suction pressure due to the stiction effect (sticky valves), which in turn resulted in more heat of compression until the sticking discharge valves opened.

- Ability increased to discuss with quantitative data which came from System 1 and process data. The calculated variables due to the pressure measurement give plenty of information for each throw on the machine which was able to determine a corrective action to take.
- Also, pressure monitoring in System 1 gave an exact timing to do maintenance for the valves using the P-V diagram.

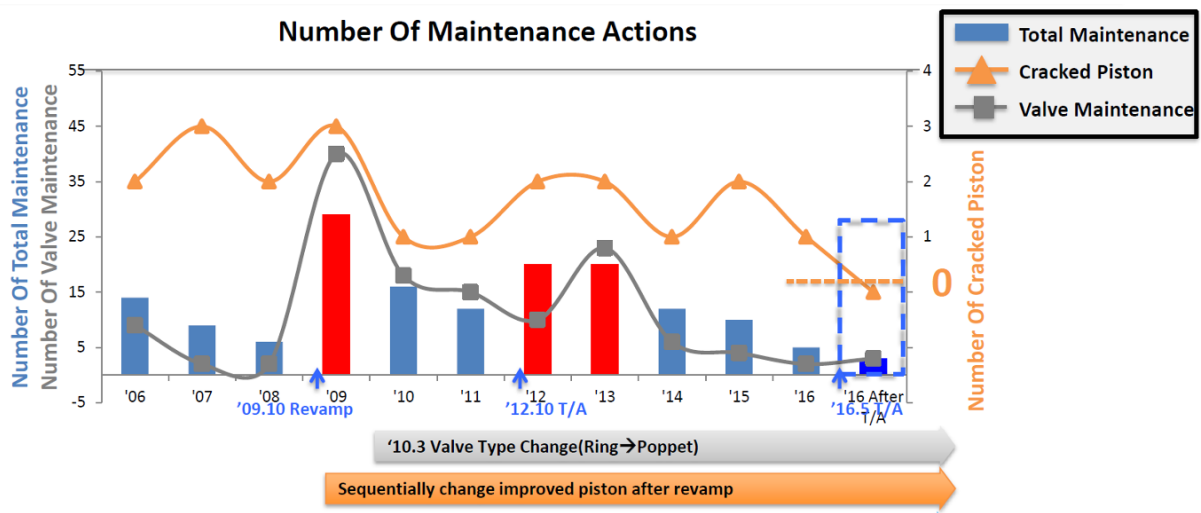
Figure 14. Outcome of the improvement

Soon after unit revamping in 2009, maintenance costs on these three compressors increased over 30 times due to the abovementioned process and mechanical problems. Through the condition monitoring improvement in 2016, the unit saw a reduction to just four maintenance incidents per year and zero cracked pistons. Those are the lowest numbers for the last 10 years, an outstanding outcome which can be attributed to the successful and collaborative cross-discipline efforts.
