# Orbit Newsletter Digital Publication

## Value of Cylinder Pressure Measurement for Reciprocating Compressor

The Aromatic process plant's Hydrogen rich gas compressors are four throw, three-stage, double-acting horizontal API618 reciprocating compressors with 40,122 Nm<sup>3</sup>/h output.

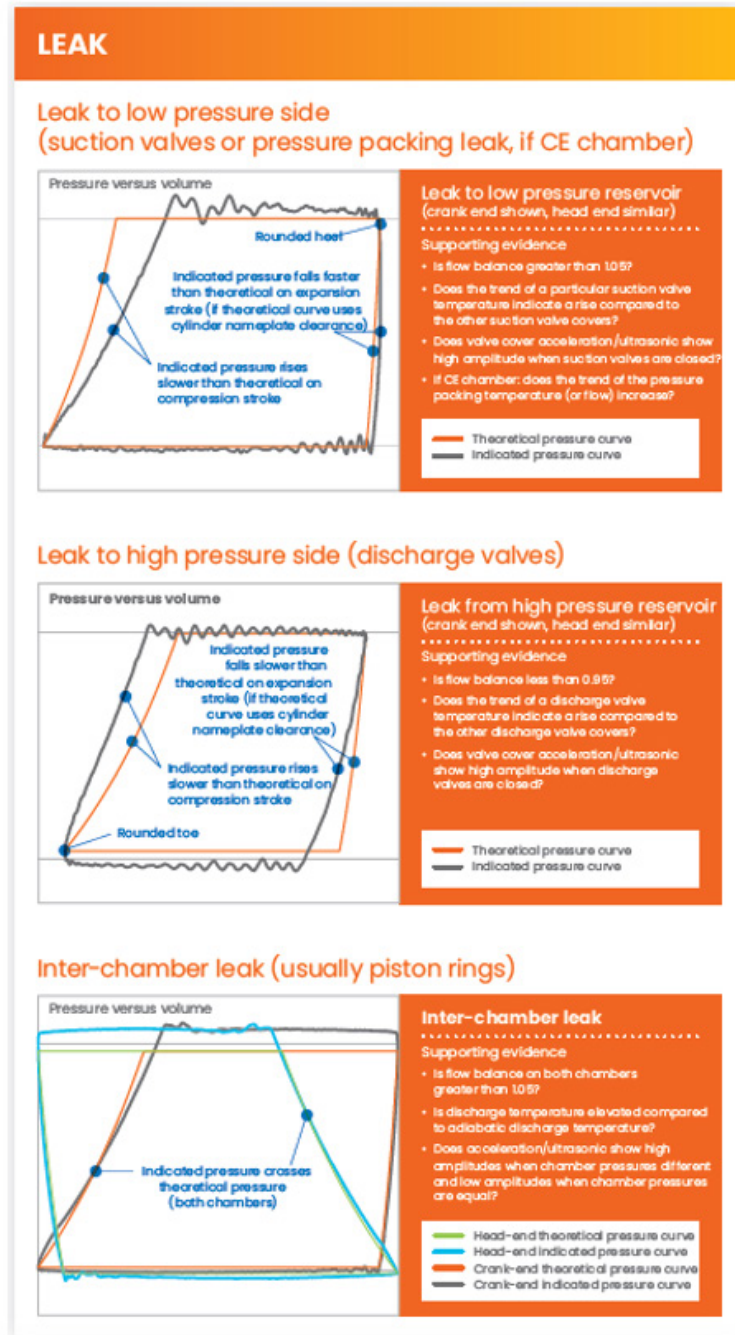
Figure 8: Flow balance is defined as Suction Capacity divided by Discharge Capacity.

If the cylinder is in perfect condition, with no leakage past the valves, packing or rings, Flow Balance is exactly 1. If process gas leaks through the suction valve, flow balance shall be higher than 1. When the flow balance is lower than 1, the discharge valve is leaking.
